## GENERAL BULLETIN GB2023005 TELESCOPIC CRANE WIRE ROPE SWAGE SOCKET FIT

Subject:	TELESCOPIC CRANE WIRE ROPE SWAGE SOCKET FIT
Attn:	IMT Distributors
From:	IMT Tech Support
Date:	November 21, 2023
Affected Models:	10000 & 12000 Telescopic Cranes

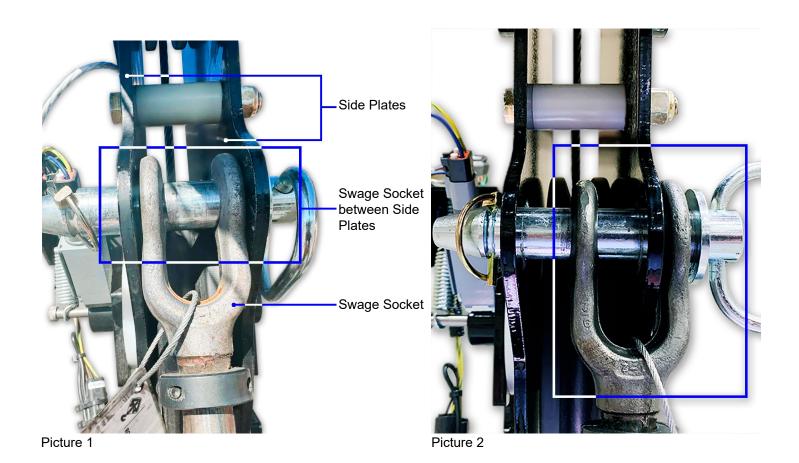
IMT has determined that due to manufacturing tolerance variation, the swage socket on the wire rope may not always fit between the side plates of the boom tip as shown in picture 1. When this occurs, the swage socket is pinned in an offset position to one side plate as shown in picture 2. There are no structural issues with this installation method.

**Instructions:** Install one 1/2" flat washer (72063132) between the nylon spacer and the inside side plate (on the opposite side of the nut).
